Service Bulletin

Service Bulletin No. 051

Replacement of P/N 69C13 Base in 65C30 Series Sealed Control Assembly

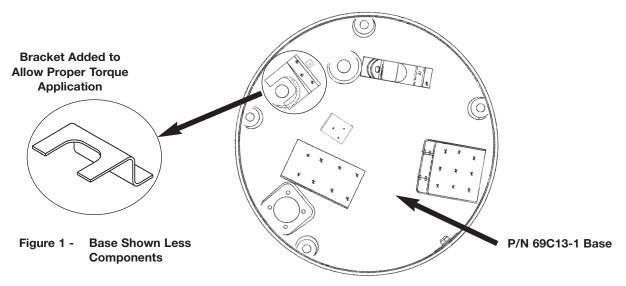
- (1) The aircraft heater fuel line may be removed and reinstalled for various reasons. HET has discovered that before or prior to overhaul of P/N 65C30 Series Sealed Control Assemblies, the hard fuel line inside the unit may be stressed, resulting in cracks or fracture.
- (2) Generally no indication of this condition is apparent unless fuel leakage is noted coming from the Sealed Control Assembly overboard drain line.
- (3) This SB is intended to provide instructions for the installation of an improved base, P/N 69C13-1, which incorporates a bracket to restrict movement of the union allowing proper torque to be established without access to the inside of the Sealed Control Assembly.
- (4) SB instructions clearly establish proper torque for the external fuel line unions.
- (5) Regulatory action is not expected.

- (1) Install new P/N 69C13-1 base as shown in Figure 1.
- (2) Using the assembly instructions found in the P/N 95C35 manual, build the assembly on the new P/N 69C13-1 base. In general, assembly is done in reverse of disassembly per the 93C95 manual with two exceptions.

- (a) When installing the fuel inlet fitting (union is on fuel filter #75) through the new base, install the existing washer (#69) and a new copper gasket (#68), P/N MS35769-8 on the fitting, then place the two flats of the fuel filter in the bracket as shown in Figure 1.
