# Alert Service Bulletin

## Alert Service Bulletin No. 085

### Heater Fuel Pump Leak Inspection and Replacement

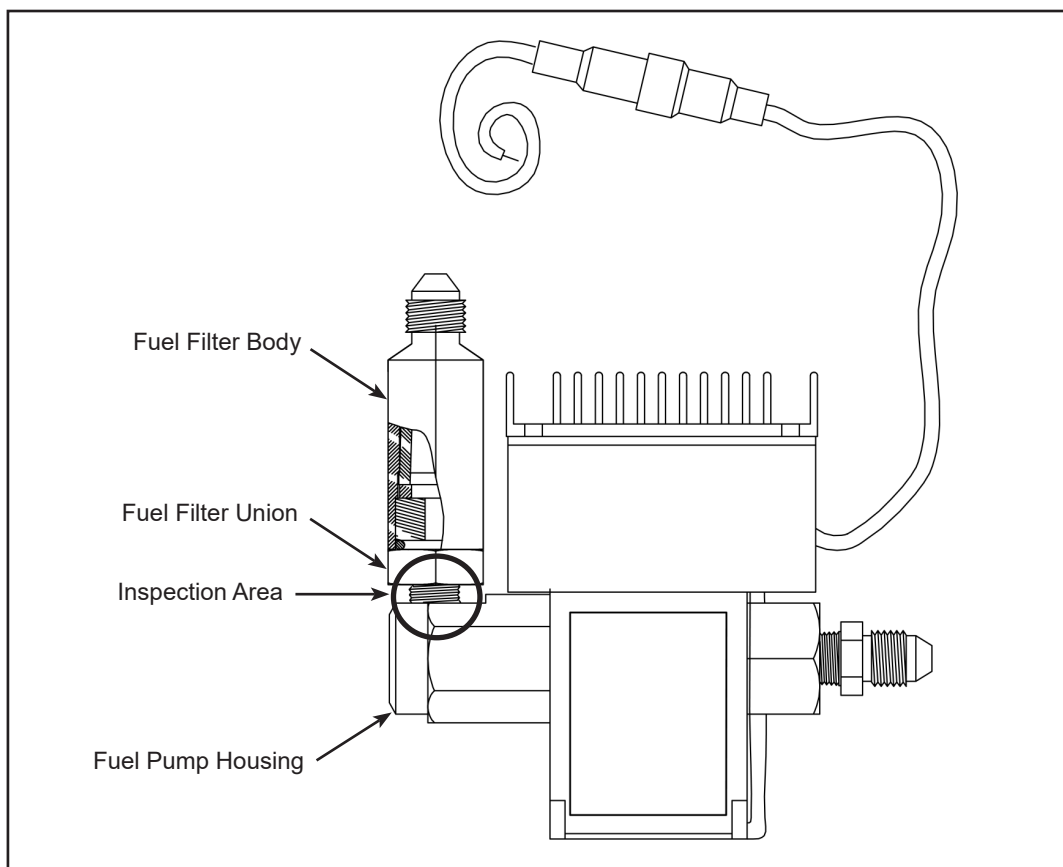
**Figure 1 - Heater Fuel Pump Inspection Area**

- (1) Fuel leakage from the fuel pump filter housing threaded connection to the fuel pump housing has been observed (see Figure 1).

- (1) Inspect the fuel pump and immediate area (Figure 1) for signs of leaking or blue fuel dye staining under the following conditions:
  - (a) Heater fuel pump de-energized;

- (b) Heater fuel pump energized;
  - (c) If equipped, energize the upstream heater fuel pump.
    - 1) If fuel leak or blue fuel dye staining is observed under any of the above conditions, continue to Corrective Action of this ASB, 3.C.(1) or 3.C.(2).

- (1) Fuel Pump Replacement
  - (a) Replace the fuel pump with a unit not affected by this ASB in accordance with appropriate aircraft maintenance manual and airframe service instructions. Continue to 3.D.(1), Return to Service.
- (2) Heater System Deactivation
  - (a) Deactivate heater system in accordance with an approved minimum equipment list applicable to the aircraft until compliance with 3.C.(1) is completed.
